WATCHUNG LAKE DAM

NJ 00767

PHASE 1 INSPECTION REPORT
NATIONAL DAM SAFETY PROGRAM
DAEW61-79-C-0011

JULY 1981

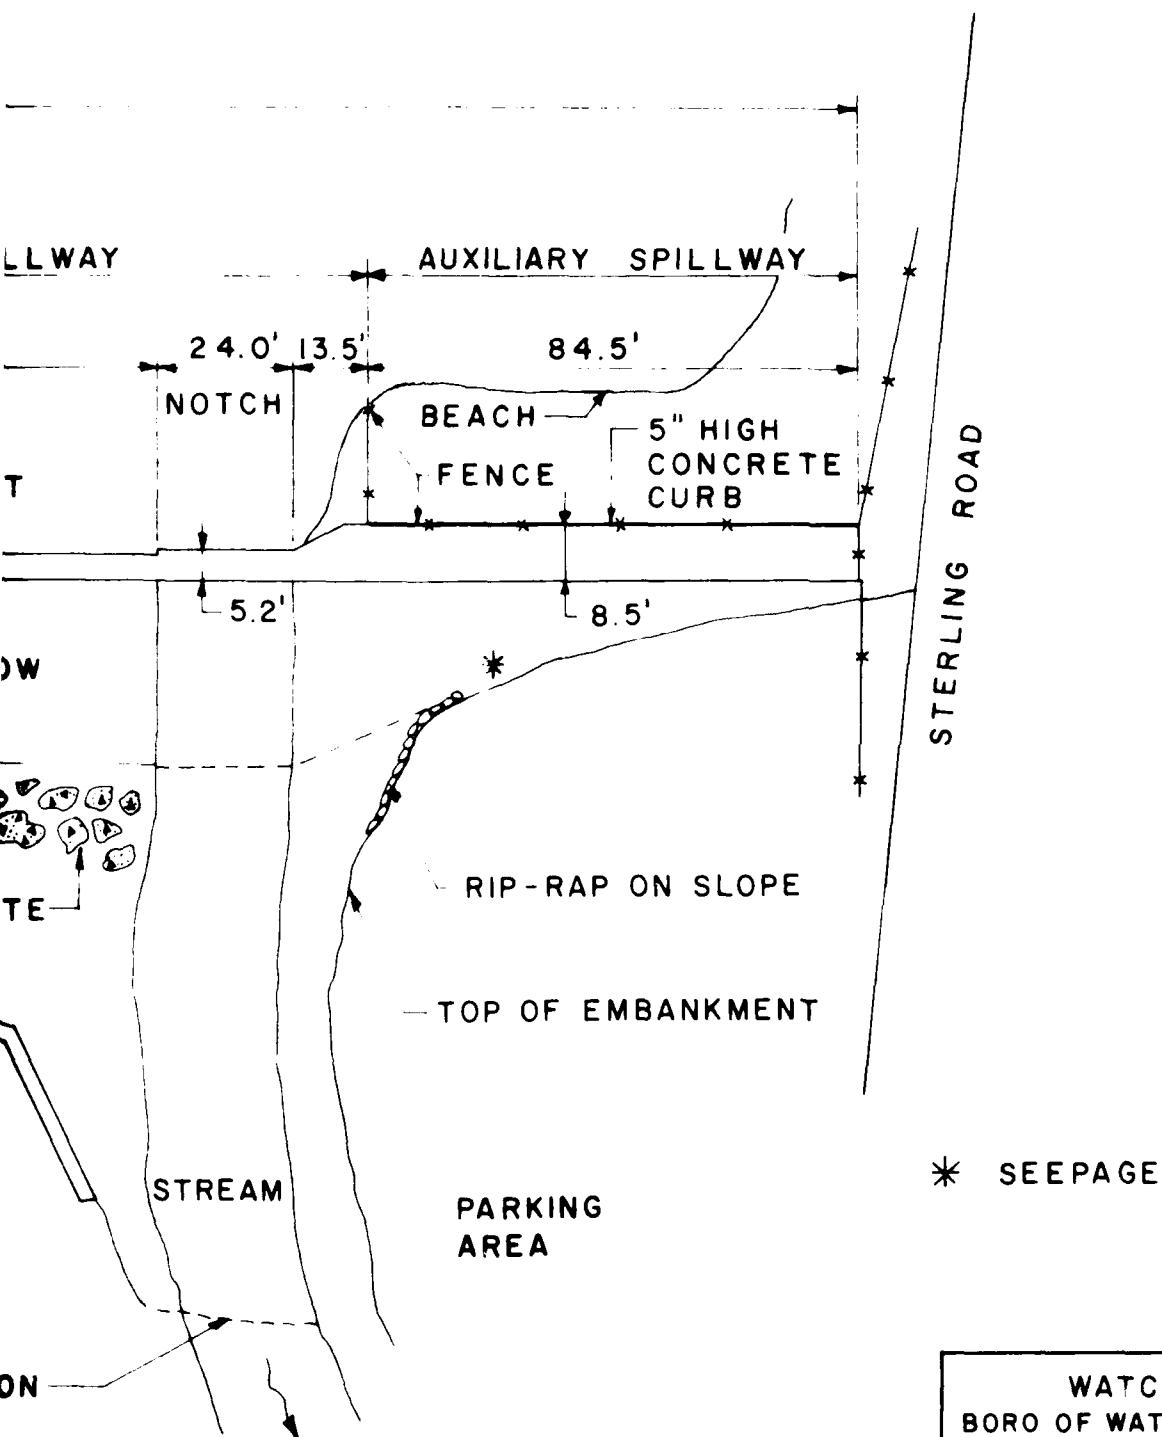
WATCHUNG LAKE DAM
 BORO OF WATCHUNG, SOMERSET CO., N.J.

SKETCH OF PLAN
 PREPARED FROM FIELD NOTES TAKEN
 DURING INSPECTION ON JAN. 8, 1981

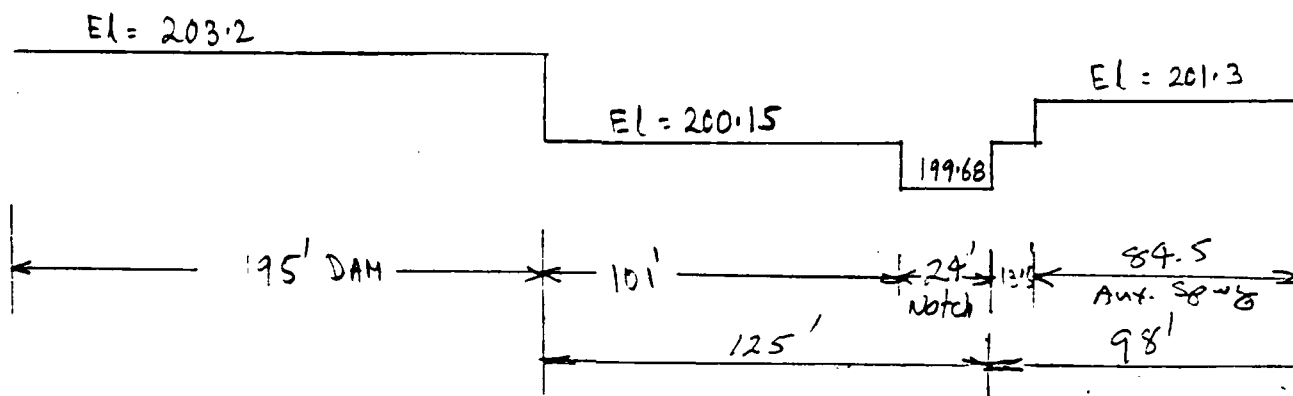
SCHEMATIC LAYOUT OF DAM

Notch. $L = 24' \quad C = 3.3 \quad Q = 3.3 \times 24 H^{3/2} = 79.2 H^{3/2}$

Main Spillway $L = 101 + 13.5 = 114.5 \quad C = 3.3$
 $Q = 3.3 \times 114.5 H^{3/2} = 378 H^{3/2}$

DAM (Left looking U.S.) $L = 195 \quad C = 2.7$
 $Q = 2.7 \times 195 H^{3/2} = 526 H^{3/2}$

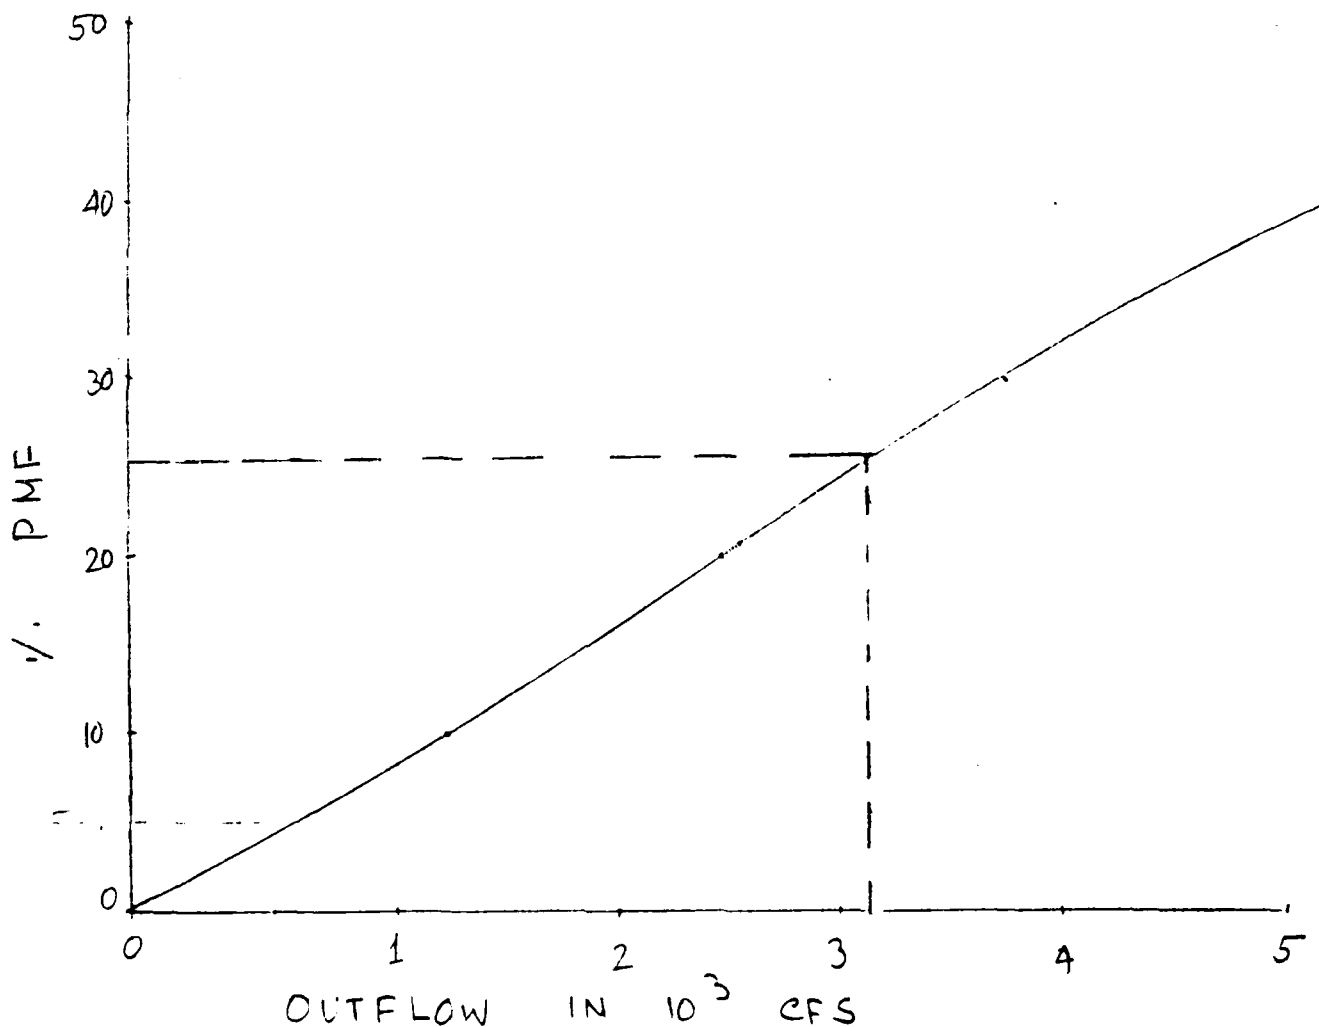
Overtopping of Dam occurs at El 203.2
 $Q = 3133$ cfs (24% of PMF)

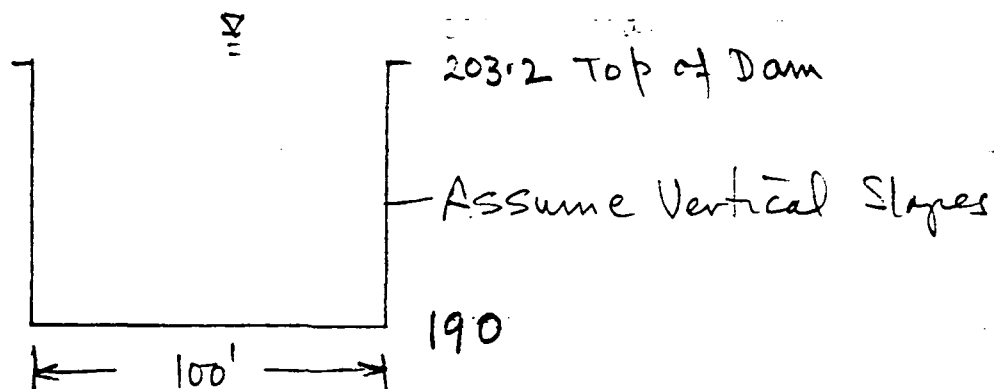
Breach Analysis

Assume breach begins to develop when
reservoir stage reaches above the Dam.
Time of failure = 16.50 hours

Effect of breach was analysed, 1,000 ft
Downstream of the Dam.

Max. stage without Dam break = 183.7
